Diagnostic imaging

High-frequency ultrasonography (22MHz) for identification and removal of a rayfish stinger

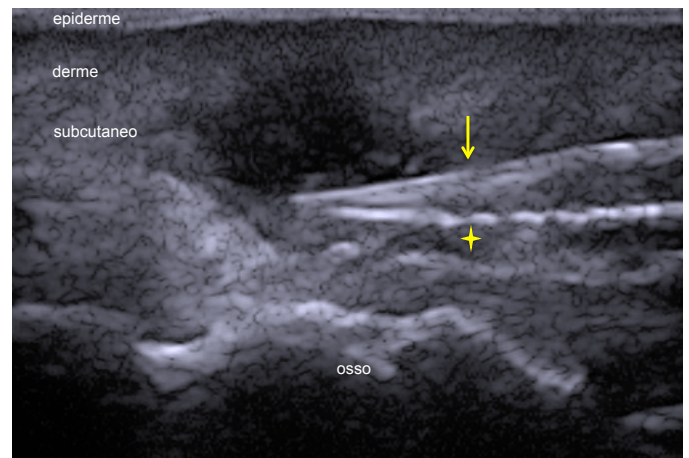
FIGURE 3: 22MHz HFUS. Hyperechogenic image with triangular shape, one side with linear structure A, and the other with serrated structure B

The examination carried out in the plantar region of the toe in question suggested the presence of an hyperechoic structure with elongated triangular shape, measuring 1.3 cm in its greater length, with one of the sides showing a linear profile and the other a serrated profile (Figure 3).

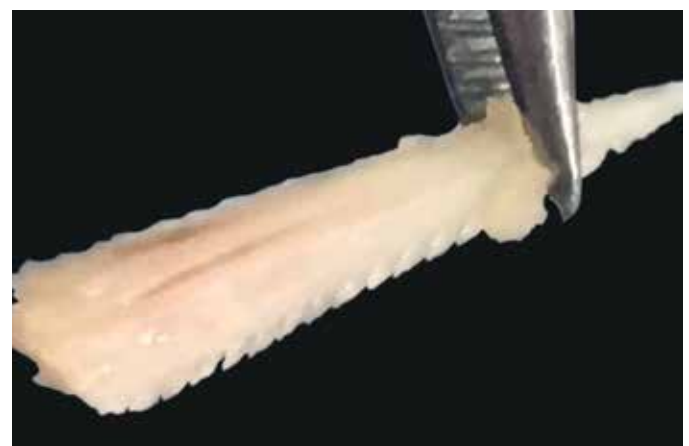
FIGURE 4: Stingray's stinger. Serrated aspect in detail seen using 22 MHz HFUS

The patient underwent the removal of the FB (Figure 4) through a small incision made in the plantar region with guidance of the ultrasound examination, under local anesthesia. Systemic antibiotic was administered (Cefadroxil, 500mg, 12/12 hours, for 7 days). The post-operative course without events.
